TEST REPORT

Mechanical & Hardgoods Laboratory

Report No. : HLO0217/2018

Product Description: POLISHED ALUMINUM RING 6" ROUND

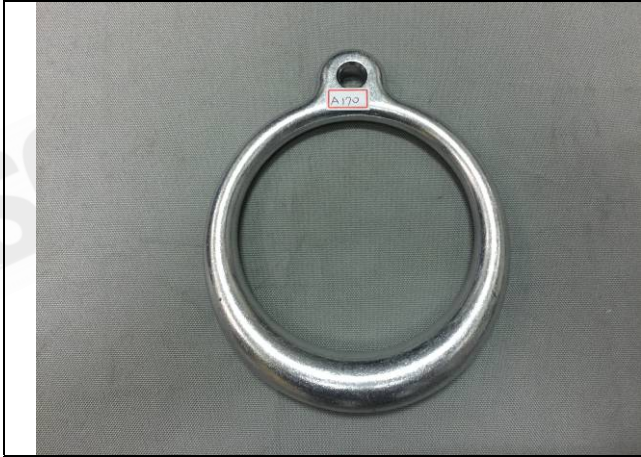
Photo A: Appearance of the sample(s)

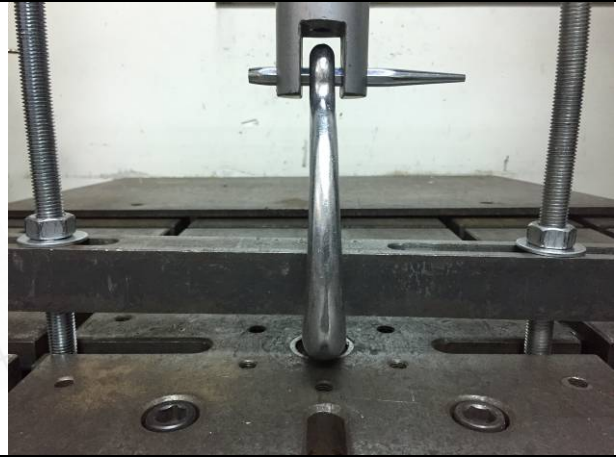
Photo B: Test setup

1. Secure the sample on the testing machine. (See photo B)
2. Apply an increasing upward force to the sample until it is damaged or up to 4,900 kgf.
3. Record the max. force and any findings.
4. Testing Machine: INSTRON 5581, Rate: 10 mm/min.

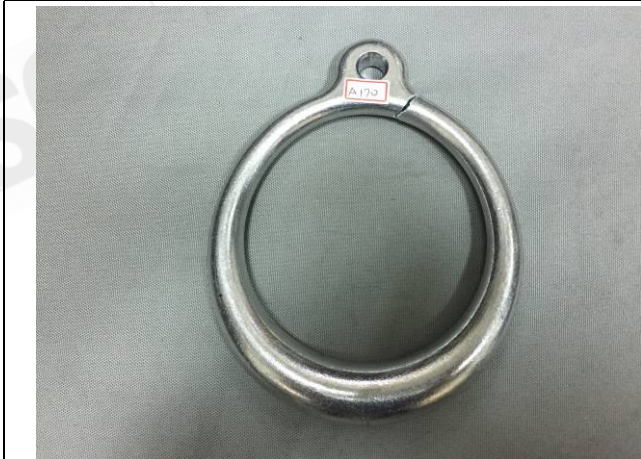
Photo C: After testing

Sample	Max. force (kgf)	Remark
POLISHED ALUMINUM RING 6" ROUND	1435.4	The sample was broken after testing. (Photo C)
