TEST REPORT

Mechanical & Hardgoods Laboratory

Report No. : HLN0252/2018

Product Description: POLISHED ALUMINUM TRIANGULAR RING LARGE STYLE

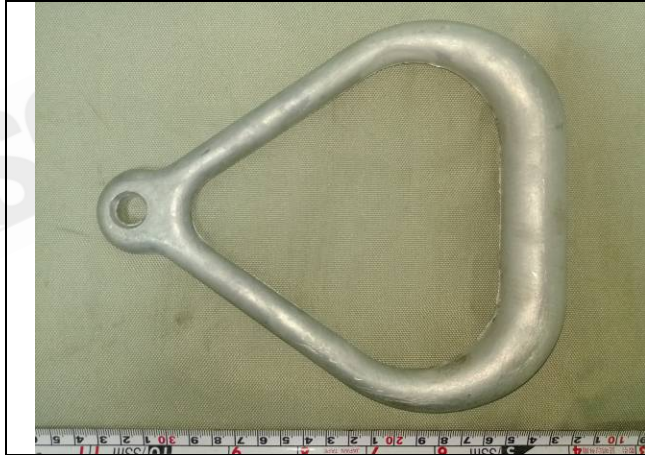
Photo A: Appearance of the sample(s)

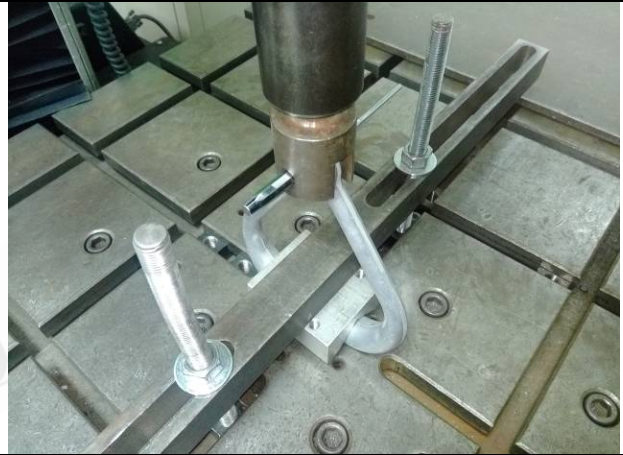
Photo B: Test setup

1. Secure the sample on the testing machine. (See photo B)
2. Apply an increasing upward force to the sample until it is damaged or up to 4,900 kgf.
3. Record the max. force and any findings.
4. Testing Machine: INSTRON 5581, Rate: 10 mm/min.

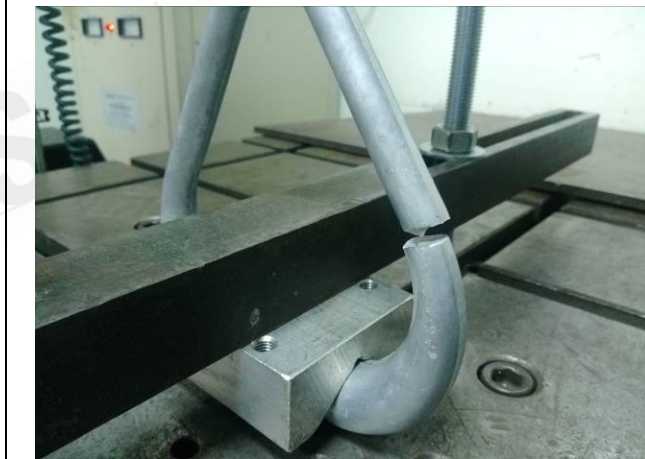
Photo C: After testing

Sample	Max. force (kgf)	Remark
#1	2494.0	The sample was broken after testing. (Photo C)
