TEST REPORT

Report No. : HL60523/2020
 Page : 1 of 2
 Date : JUL. 07, 2020

Product Description: TRIANGULAR ALUMINUM TRAPEZE RING-PLASTISOL YELLOW
Style/Item No.: A185Y
Country of Origin: TAIWAN

Test Requested: Pulling test

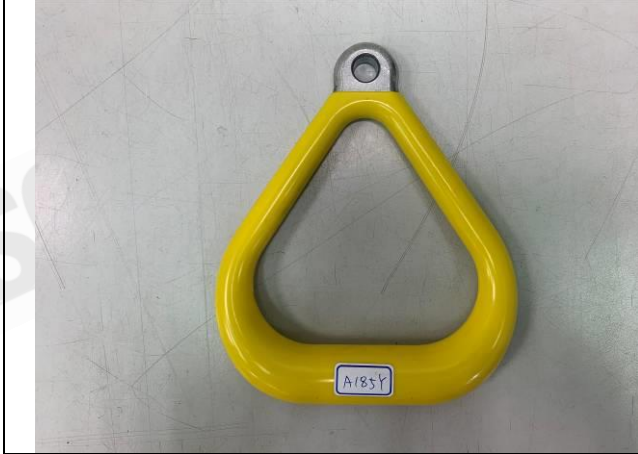
Photo A: Appearance of the sample

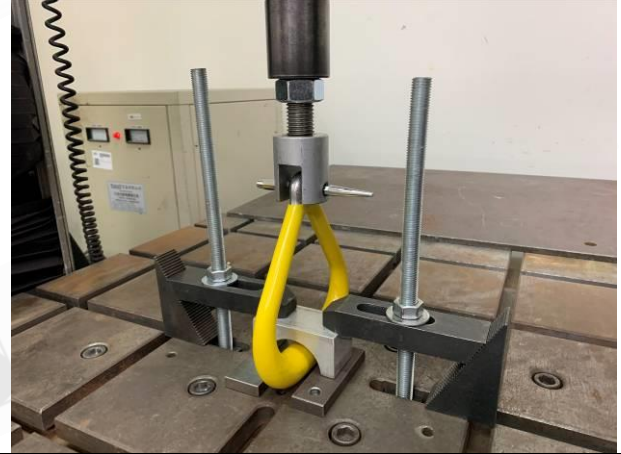
Photo B: Test setup

1. Secure the sample on the testing machine. (See photo B)
2. Apply an increasing upward force to the sample until it is damaged or up to 4,900 kgf.
3. Record the max. force and any findings.
4. Testing Machine: INSTRON 5581, Rate: 10 mm/min.

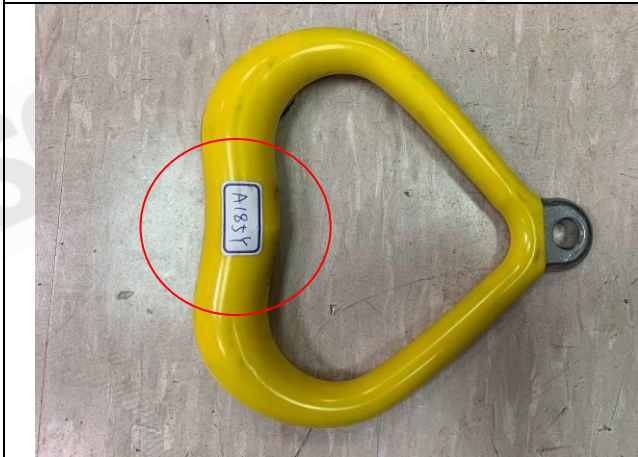
Photo C: After testing

| Sample | Max. force (kgf) | Remark |
|---|---|---|
| TRIANGULAR ALUMINUM TRAPEZE RING-PLASTISOL YELLOW | 1,437 | The sample was damaged after testing. (Photo C) |
