TEST REPORT

Report No. : HL50340/2018

Product Description: SAFETY CHAIN W/PLASTIC HOSE

Test Requested: Pulling test

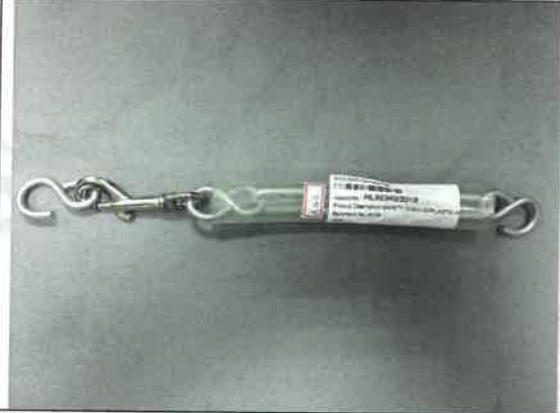
<p>Photo A: Appearance of the sample(s)</p>	<p>Photo B: Test setup</p>

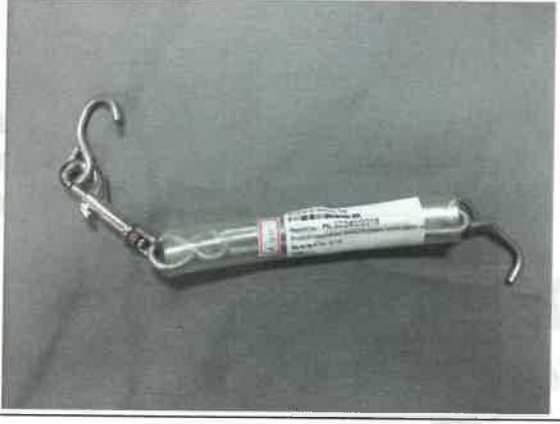
<p>---</p>
<p>Photo C: After testing</p>	<p>---</p>

Sample	Max. force (kgf)	Remark
SAFETY CHAIN W/PLASTIC HOSE	87.7 193	The sample was broken after testing. (Photo C)
