Material & Engineering Laboratory-Taichung

TEST REPORT

REPORT NO : TK-18-01470
 PAGE NO : 1 OF 2
 DATE : Mar. 29, 2018

Applicant FAIR BOSS COMPANY
Address No.31, Alley 24, Lane 92, YangGuang St., Neihu District, Taipei City, Taiwan, R.O.C.
Product Description 3-1/2" TIRE SWIVEL
Product Type A134
Product Color PAINT(RED)
Supplier MASTER PLAN INDUSTRY CO., LTD.
Product Submitted By MASTER PLAN INDUSTRY CO., LTD.
Received Date Mar. 21, 2018
Tested Date Mar. 21, 2018~Mar. 28, 2018
Test Method: 1. Fix sample on the testing machine.
 2. Test rate (10 mm/min)
Remark: The information mentioned in the above section is provided by Client (Exclude Date of Sample Received and Date of Testing)

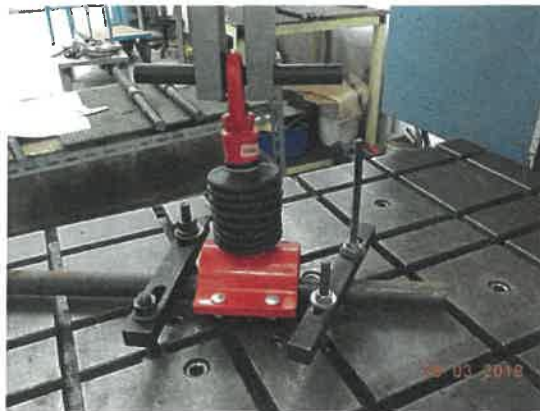
Tensile test

Sample Name	Tensile load (lbf)
3-1/2" TIRE SWIVEL	15000
