### TEST REPORT

Report No. : HL10474/2018

Product Description: POLISHED ALUMINUM TRIANGULAR RING LARGE STYLE

Test Requested: Pulling test

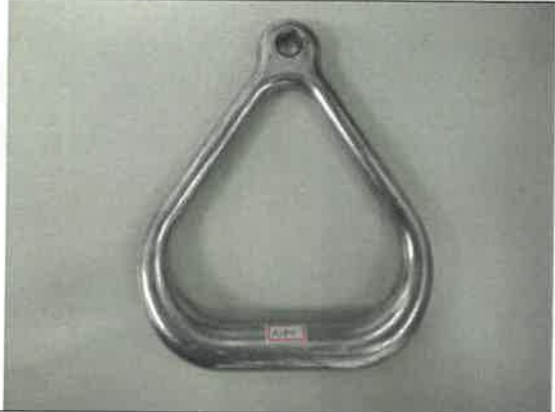
<p>Photo A: Appearance of the sample</p>	<p>Photo B: Test setup</p>

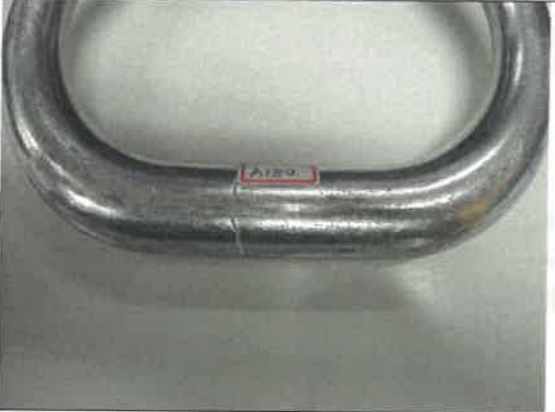
<p>---</p>
<p>Photo C: After testing</p>	<p>---</p>

Sample	Max. force (kgf)	Failure mode
POLISHED ALUMINUM TRIANGULAR RING LARGE STYLE	1769.3 <i>3896.3</i>	The sample was broken after testing. (Photo C)
