TEST REPORT

Report No. : HL70502/2017

The following merchandise was submitted and identified by the applicant as:Product Description: POLISHED ALUMINUM TRIANGULAR RING LARGE STYLEStyle/Item No.: A180Country of Origin: TAIWAN**We have tested the submitted sample as requested and the following results were obtained:**Test Requested: Pulling testTest Method:

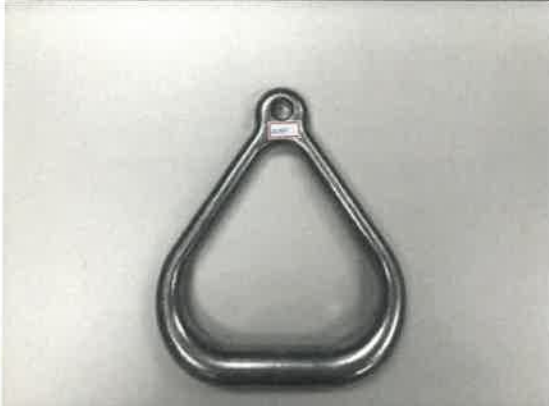
<p>Photo A : Appearance of the sample</p>	<p>Photo B : Test setup</p>

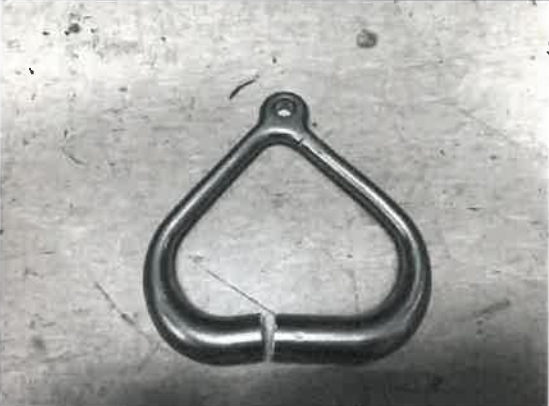
<p>---</p>
<p>Photo C : After testing</p>	<p>---</p>

Sample	Max. force (kgf)	Failure mode
POLISHED ALUMINUM TRIANGULAR RING LARGE STYLE	3107.17 6835	The sample was broken after testing. (Photo C)
