TEST REPORT

Report No. : HL10455/2018

The following merchandise was submitted and identified by the applicant as:Product Description: STEERING WHEEL PLASTIC GREENStyle/Item No.: ASW-GCountry of Origin: TAIWAN**We have tested the submitted sample as requested and the following results were obtained:**Test Requested: Pulling TestTest Method:

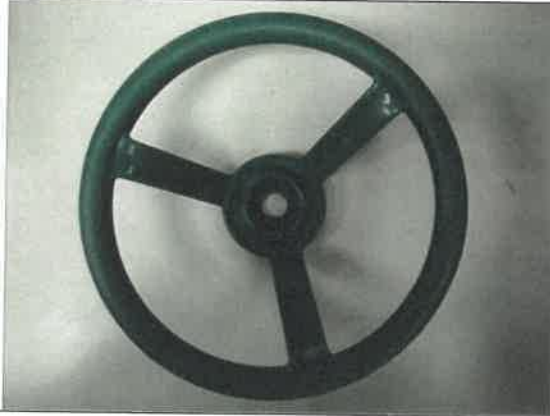
<p>Photo A: Appearance of the sample</p>	<p>Photo B: Test setup</p>

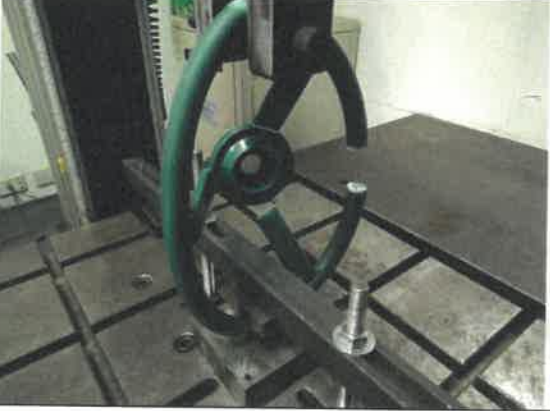
<p>---</p>
<p>Photo C: Failure mode</p>	<p>---</p>

Sample	Max. force (kgf)	Failure mode
STEERING WHEEL PLASTIC GREEN	539.3 1186 (handwritten)	The sample was damaged after testing. (See photo C)
