TEST REPORT

Report No. : HL50434/2018

Product Description: H-SHACKLE GALV

Test Requested: Pulling test

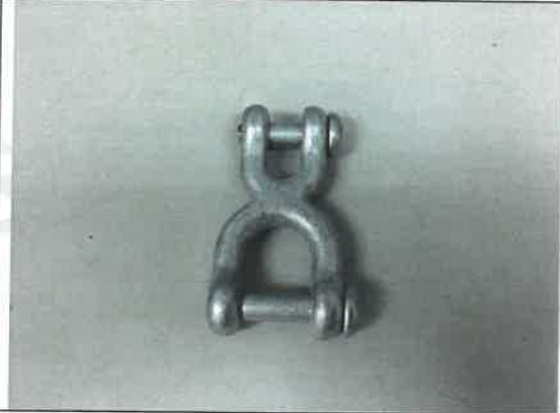
<p>Photo A: Appearance of the sample(s)</p>	<p>Photo B: Test setup</p>

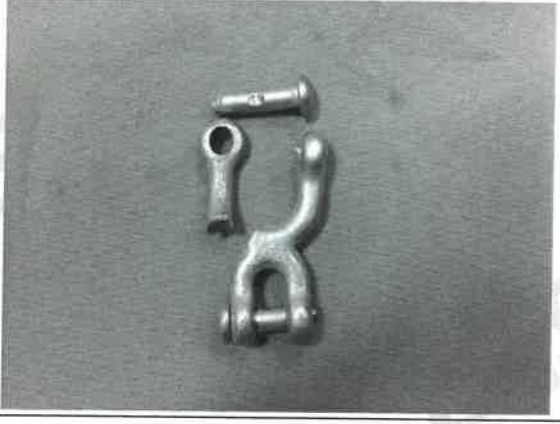
<p>---</p>
<p>Photo C: After testing</p>	<p>---</p>

Sample	Max. force (kgf)	Remark
H-SHACKLE GALV	2647.2 <i>5823</i>	The sample was broken after testing. (Photo C)
