**TEST REPORT**

Report No. : HL30088/2018

Product Description: ROCK GRIP SET OF GREEN

Test Requested: Compression test

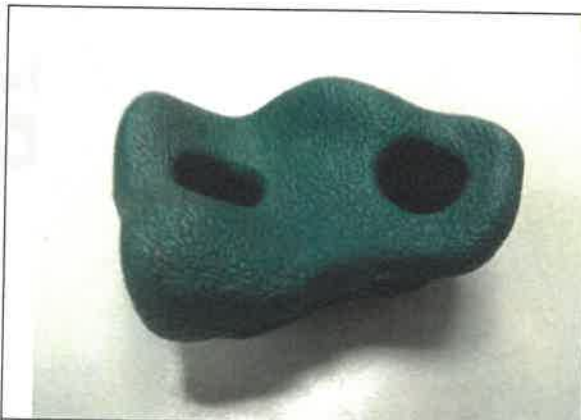
Photo A: Appearance of the sample (front view)

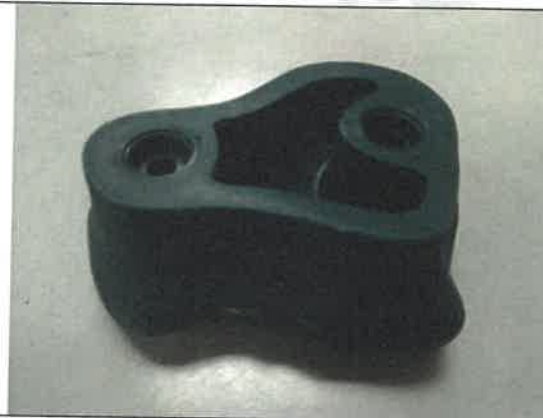
Photo B: Appearance of the sample (back view)

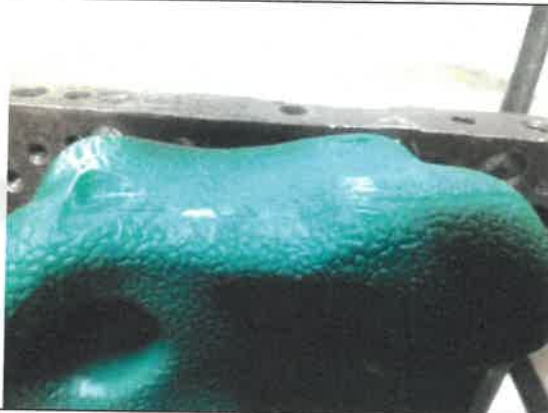
Photo D: After testing

Sample	Max. force (kgf)	Failure mode
ROCK GRIP SET OF GREEN	1258.9 <i>2769 LAD</i>	The fixed steel bolt was broken, but the sample was not broken after testing . (Photo D)
