TEST REPORT

Mechanical & Hardgoods Laboratory

Report No. : HL50155/2017

Product Description: ROCK GRIP SET OF GREEN (YELLOW)

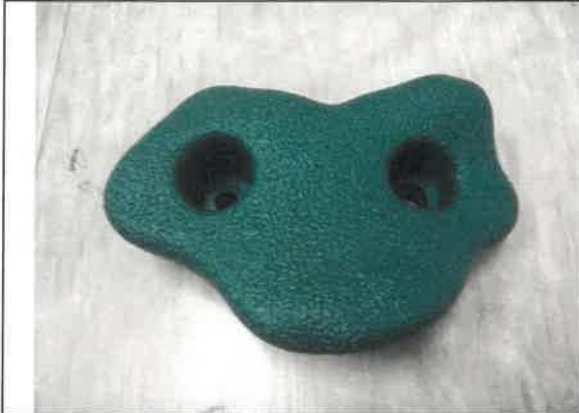
Photo A : Appearance of the sample (Front)

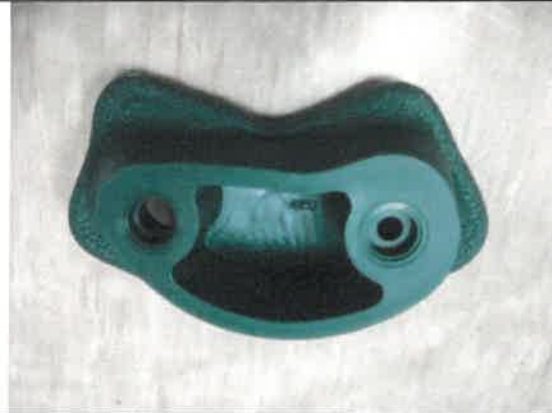
Photo B : Appearance of the sample (Back)

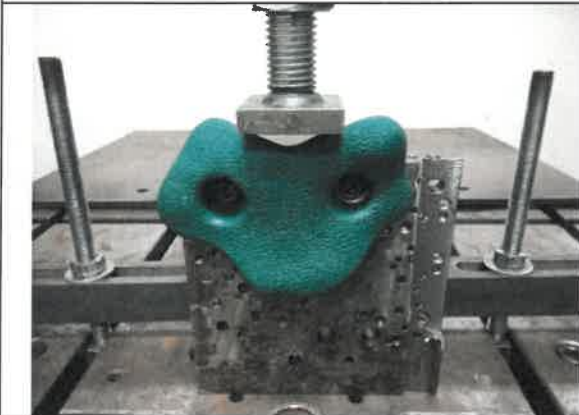
Photo C : Test setup

- Test Method:
1. Secure the sample on the testing machine. (As shown in photo C)
 2. Apply an increasing downward force to the sample until it is damaged.
 3. Record the max. force.
 4. Testing Machine: INSTRON 5581, Rate: 10 mm/min.
 5. Loading Pad: 50 mm x 50 mm steel surface

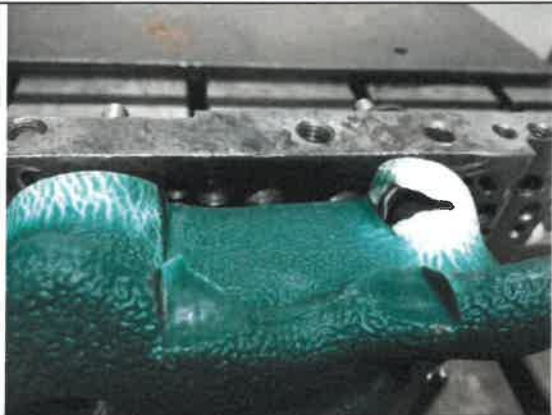
Photo D : After testing

Sample	Max. force (kgf)	Result
ROCK GRIP SET OF GREEN(YELLOW)	2117.5 4658	The sample was damaged after testing. (As shown in photo D)
