TEST REPORT

Report No. : HL60002/2018

Product Description: TOT FULL BUCKET RESI BLUE(GREEN, RED) WITHOUT HARDWARE

Test Requested: Pulling test

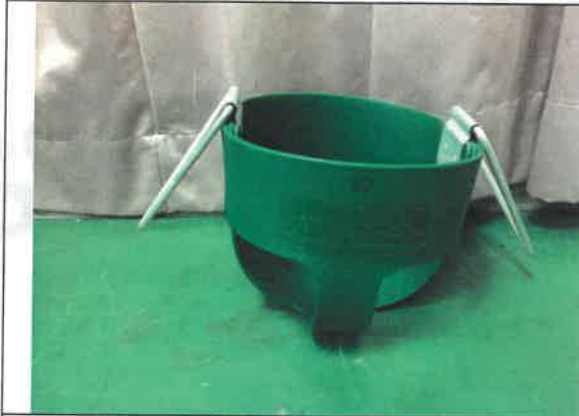
Photo A: Appearance of the sample(s)

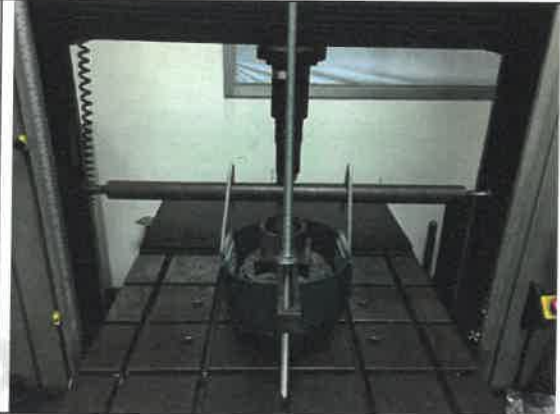
Photo B: Test setup

1. Secure the sample on the testing machine. (See photo B)
2. Apply an increasing upward force to the sample until it is damaged or up to 4,900 kgf.
3. Record the max. force and any findings.
4. Testing Machine: INSTRON 5581, Rate: 10 mm/min.
