## TEST REPORT

Report No. : HL30157/2018

Product Description: 2-3/8" DUCTILE W/SHACKLE GALV.

Test Requested: Pulling test

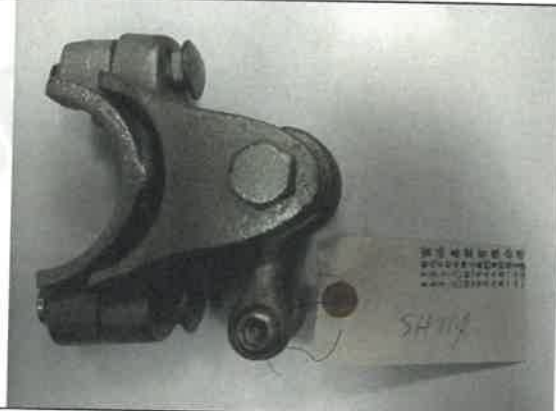
| <p>Photo A: Appearance of the sample</p> | <p>Photo B: Test setup</p> |

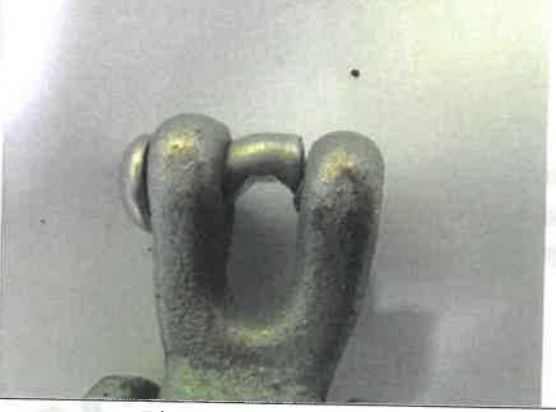
| <p>Photo C: After testing</p> | <p>---</p> |

| Sample | Max. force (kgf) | Remark |
|---|---|--|
| 2-3/8" DUCTILE W/SHACKLE GALV. | 3779.8<br><i>8315 (handwritten)</i> | The sample was broken after testing. (Photo C) |
