TEST REPORT

No. : SUIN1807006514ML

Sample Name : 2-3/8"PIPE HANGER- DUCTILE IRON
 Product Specification : SH115
 Product or Lot No. : PO#17831stk cn
 Manufacturer : LEADER HARDWARE(KUN SHAN) CO., LTD.
 Buyer : JENSEN SWING PRODUCTS
 Material and Mark : STEEL

Test Required : Tensile Test
 Date of Receipt : Jul 23, 2018
 Testing Start Date : Jul 23, 2018
 Testing End Date : Jul 30, 2018
 Test result(s) : For further details, please refer to the following page(s)
 (Unless otherwise stated the results shown in this test report refer only to the sample(s) tested)

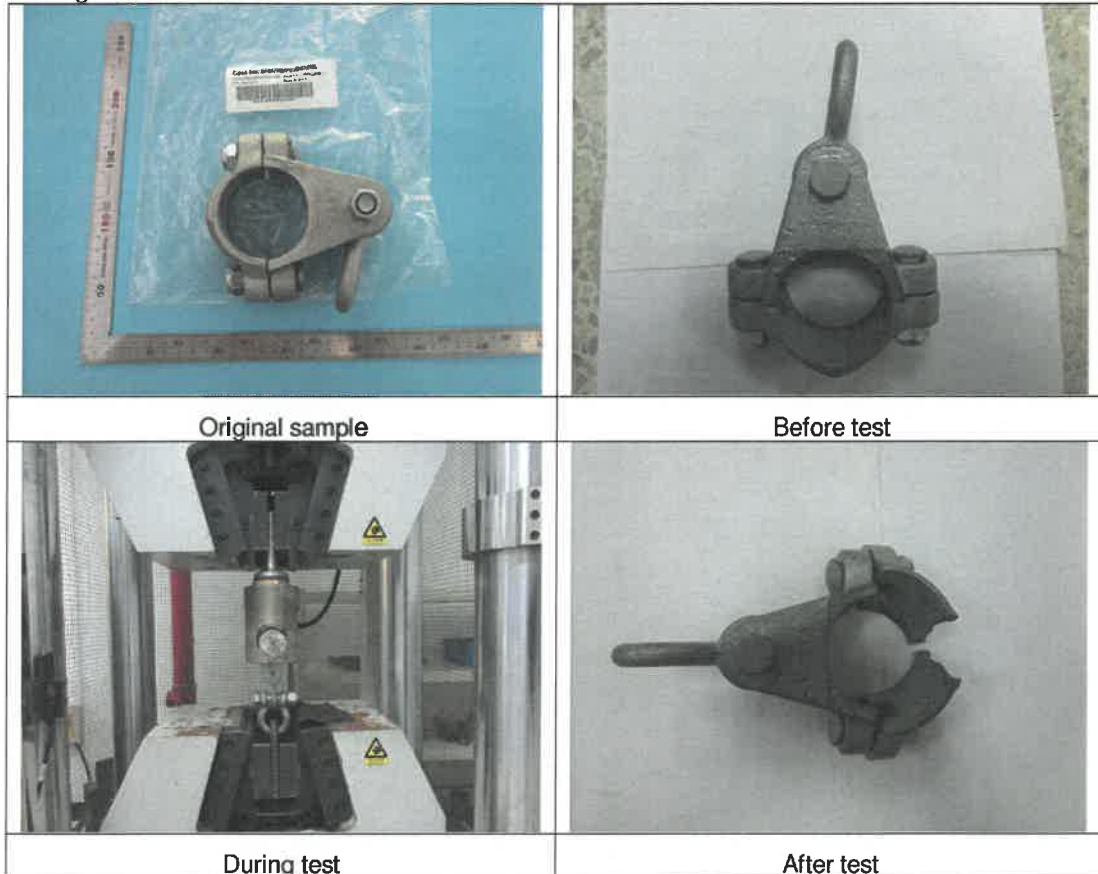
Testing Photos:

Step 1. Fix the sample on the test equipment, please see the test photos;

Step 3. Check the location of fracture and record the force.

Sample	Broken force (lbf)	Location of fracture
1#	5148.4	See photos
