TEST REPORT

No. : SUIN1804002337ML

Sample Name : 2-3/8"WRAP AROUND HANGER
 Product Specification : SH116
 Product or Lot No. : PO#17775var
 Manufacturer : LEADER HARDWARE(KUN SHAN) CO., LTD.
 Buyer : JENSEN SWING PRODUCTS
 Material and Mark : STEEL

Test Required : Tensile Test
 Date of Receipt : Apr 04, 2018
 Testing Start Date : Apr 04, 2018
 Testing End Date : Apr 17, 2018
 Test result(s) : For further details, please refer to the following page(s)
 (Unless otherwise stated the results shown in this test report refer only to the sample(s) tested)

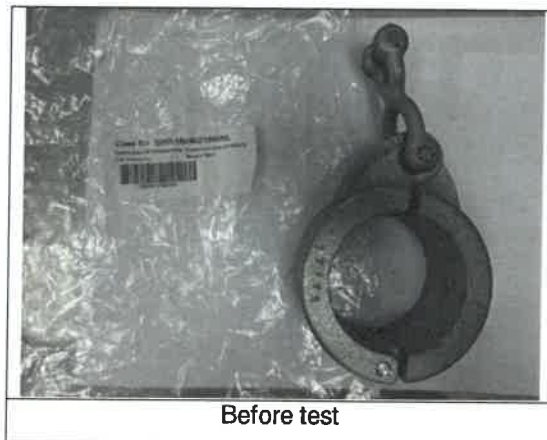
Testing Photos:

Step 1. Fix the sample on the test equipment, please see the test photos;

Sample	Broken force (lbf)	Location of fracture
1#	9,530	See the photo

Step 2. Drawing at the certain rate until the sample was broken;

Step 3. Check the location of fracture and record the force.
