TEST REPORT

No. : SUIN1804002336ML

Tensile Test:

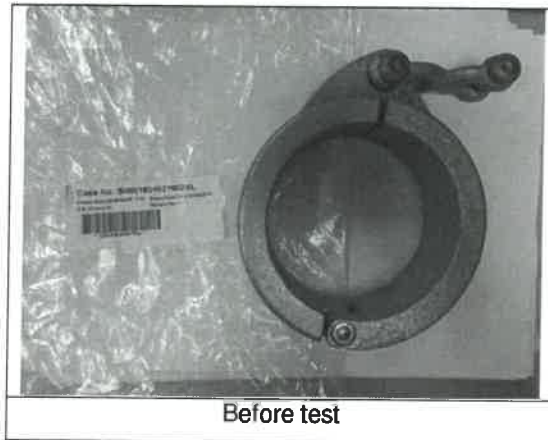
Testing Photos:

Step 1. Fix the sample on the test equipment, please see the test photos;

Sample	Broken force (lbf)	Location of fracture
1#	10,169	See the photo

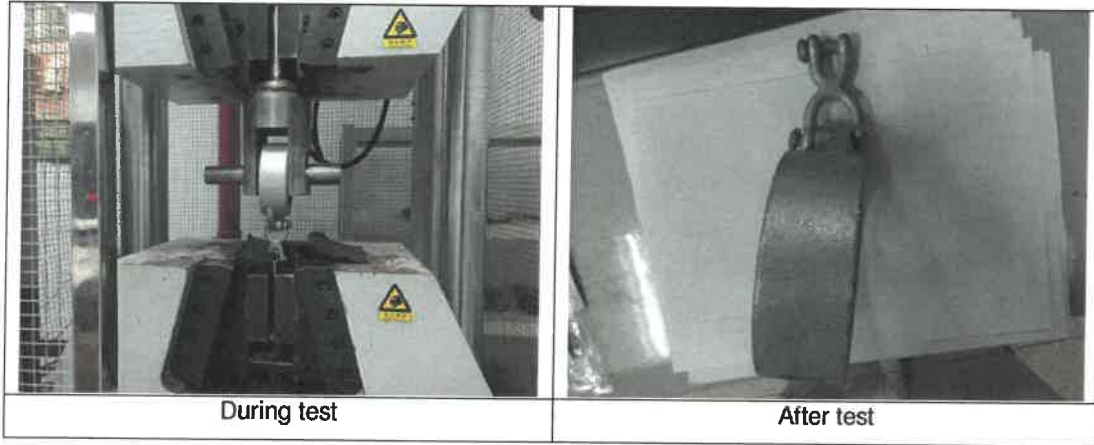
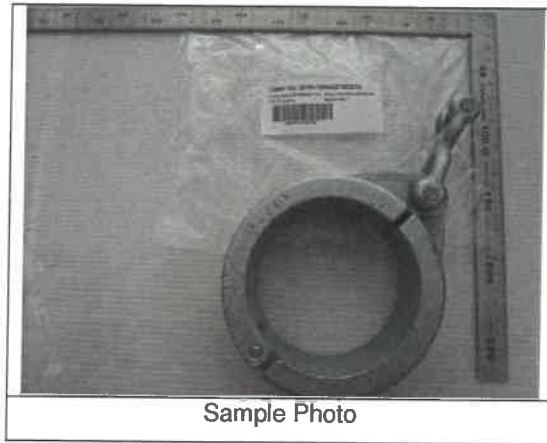
Step 3. Check the location of fracture and record the force.
