TEST REPORT

No. : SUIN1709005572ML

Sample Name : NONWRAP HANGER 3-1/2"(new style)
 Product Specification : SH126
 Product or Lot No. : PO#17760sh126
 Manufacturer : LEADER HARDWARE(KUN SHAN) CO., LTD.
 Buyer : JENSEN SWING PRODUCTS
 Material and Mark : STEEL

Test Required : Tensile Test
 Date of Receipt : Sep 12, 2017
 Testing Start Date : Sep 12, 2017
 Testing End Date : Sep 20, 2017
 Test result(s) : For further details, please refer to the following page(s)
 (Unless otherwise stated the results shown in this test report refer only to the sample(s) tested)

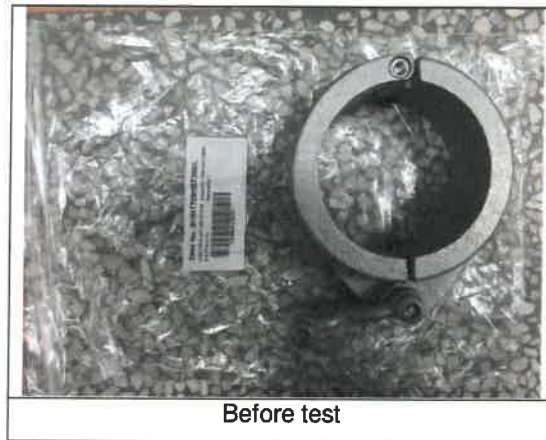
Test Photos:

Step 1. Fix the sample on the test equipment, please see the test photos;

Step 2. Drawing at the certain rate until the sample was broken;

Step 3. Check the location of fracture and record the force.

Sample	Broken force (lbf)	Location of fracture
1#	7,388	See photos
