TEST REPORT

Report No. : HL50451/2018

Product Description: PLASTIC BLACK TRAPEZE RING

Test Requested: Pulling test

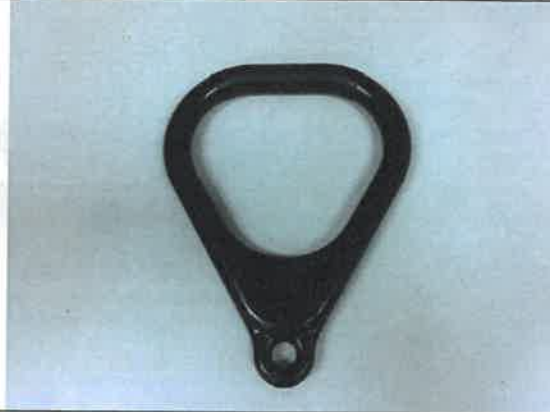
<p>Photo A: Appearance of the sample(s)</p>	<p>Photo B: Test setup</p>

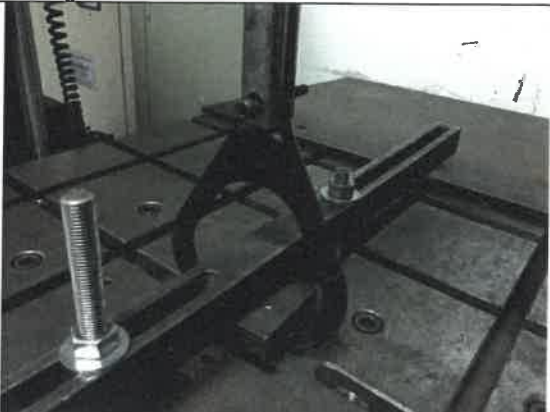
1. Secure the sample on the testing machine. (See photo B)
2. Apply an increasing upward force to the sample until it is damaged or up to 4,900 kgf.
3. Record the max. force and any findings.
4. Testing Machine: INSTRON 5581, Rate: 10 mm/min.

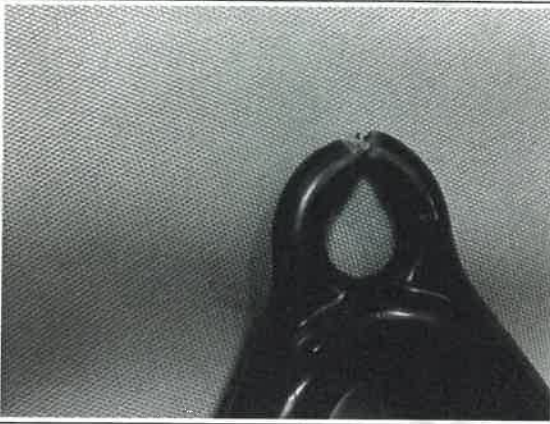
Sample	Max. force (kgf)	Remark
PLASTIC BLACK TRAPEZE RING	208.6 <i>459 (200)</i>	The sample was broken after testing. (Photo C)

<p>---</p>
<p>Photo C: After testing</p>	<p>---</p>
