TEST REPORT

Report No. : HL90240/2017

Product Description: PLASTIC(BLACK)TRAPEZE RINGStyle/Item No.: STR-BLKCountry of Origin: TAIWAN

Test Requested: Pulling test

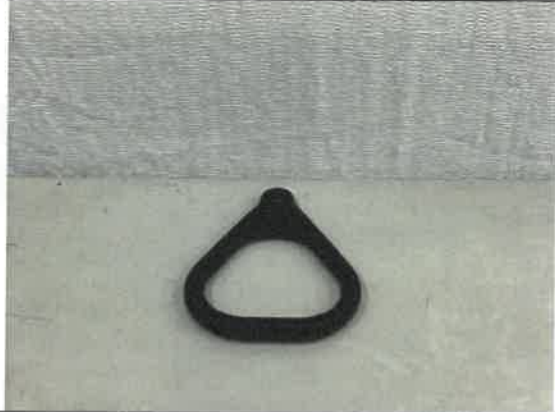
<p>Photo A : Appearance of the sample</p>	<p>Photo B : Test setup</p>

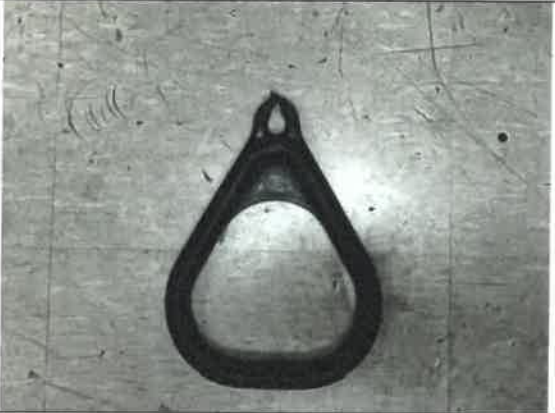
<p>---</p>
<p>Photo C : After testing</p>	<p>---</p>

Sample	Max. force (kgf)	Failure mode
PLASTIC(BLACK) TRAPEZE RING	239.1	The sample was broken after testing. (Photo C)
